Corrosion Resistance Performance of Supplied Parts Exposed To Neutral Salt Spray Conditions

TSR 140363

Customer GERSHWIN P/L

Component/s 2 x Extrusion pieces

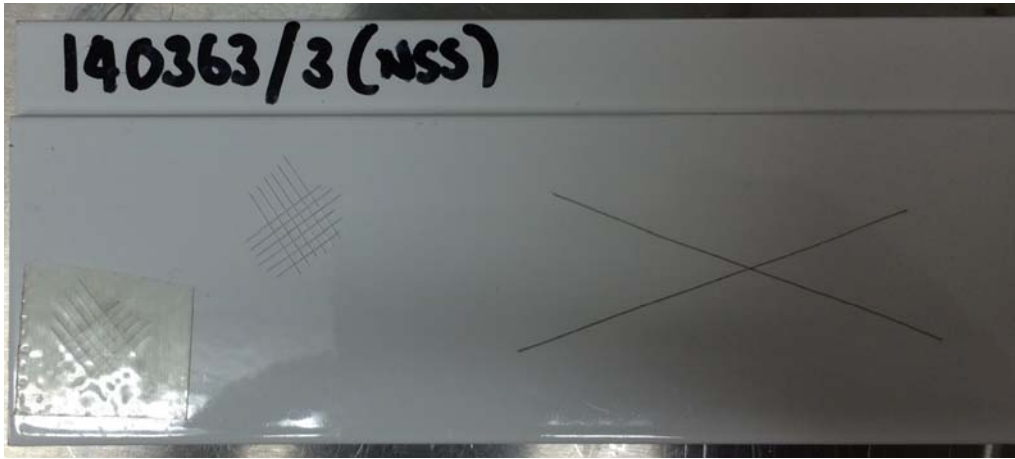
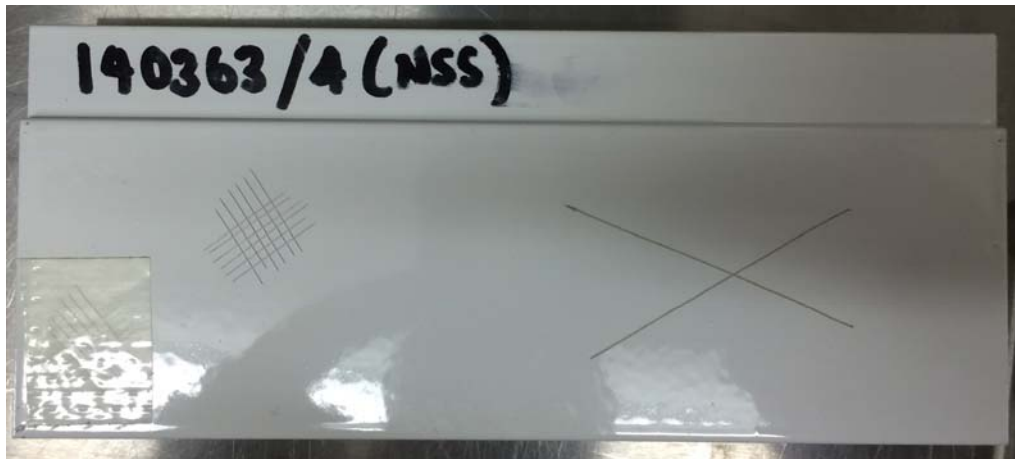
Photographs – NSS Extrusion pieces

Initial film properties tested indicate that all pieces passed for adhesion, solvent resistance and film builds, except that there were a few regions on the frames that had areas of low film build. All parts have passed 1000 hours Neutral Salt Spray exposure with no surface defects in the scribed or general areas.
